MILFOIL CONTROL AT GALWAY LAKE

Transcript of presentation May 16, 1991, *Conference on Nuisance Plants in Aquatic Environments: Ecology and Management*, Sponsored by the Hudson River Environmental Society, Inc., in cooperation with the Freshwater Institute of RPI.

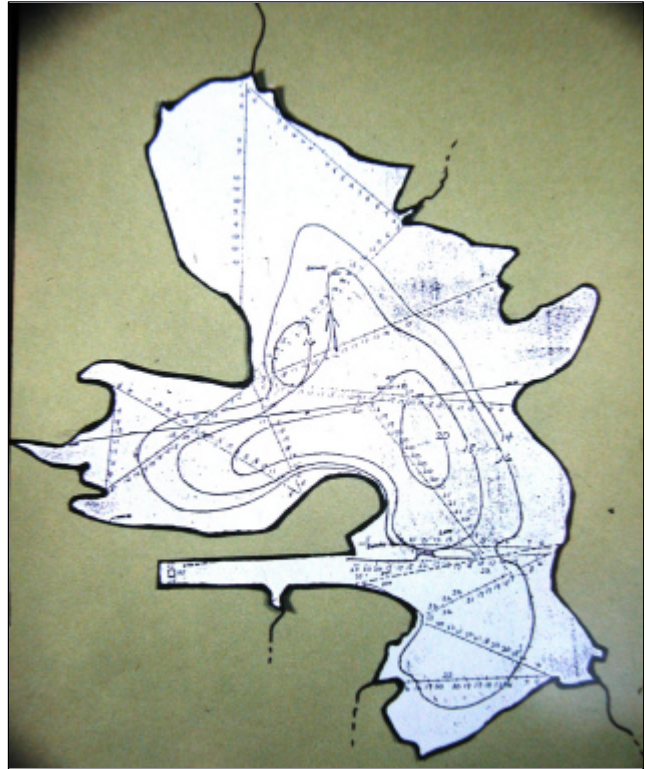
SLIDE #2 - GALWAY LAKE

Galway Lake is irregularly shaped, eight-tenths of a square mile of surface area, and more or less a mile across the widest stretches. Maximum depth is about 25 feet. There are several streams flowing in, and one outlet stream from the dam at the end of this channel (point). This man-made reservoir was originally built more than one hundred years ago to support water-powered industry downstream toward Amsterdam. It was built in two phases, and the original dike is below the present surface at this location (point)

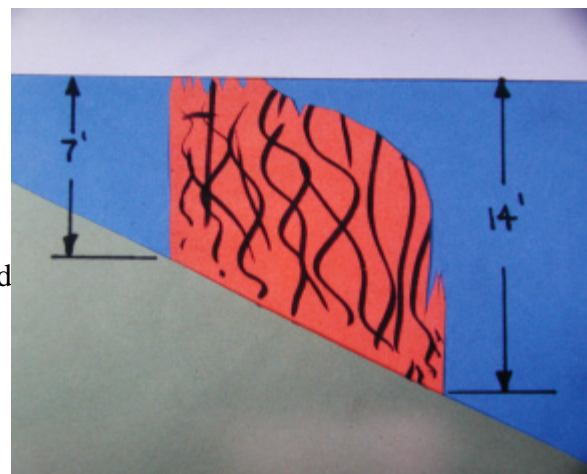
SLIDE #8 - TRAVERSE SECTION

Plus or minus a foot or so, the growth started at seven foot depth, and ended at fourteen feet. Traverses were made from shallow to deep, soundings being taken at the first and last plants observed. The deepest plants were generally isolated and stunted, compared to the thick, surface-penetrating growth in the shallower part of the field.

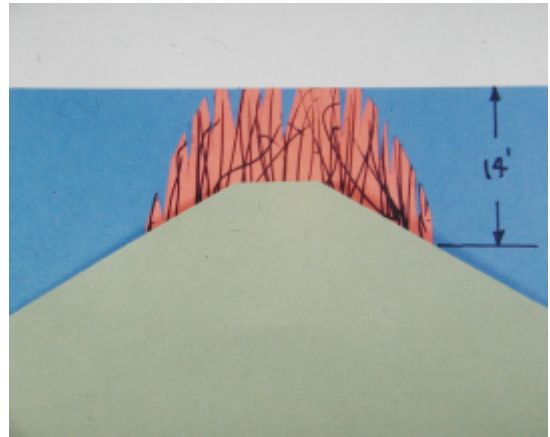
SLIDE #9 - TRAVERSE ACROSS
OLD DAM (DEEP SECTION)

One of the thickest and most obvious milfoil growth areas was over the old dike. This field all but cut the lake into two isolated sections. Getting through it was difficult or impossible by swimming, rowing, or sailing, except for one narrow opening where the old dike had been breached many years before.

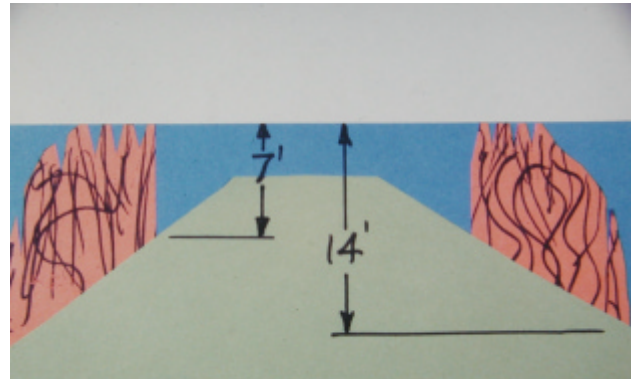
SLIDE #10 - TRAVERSE ACROSS
OLD DAM (SHALLOW SECTION)

Where the top of the old dike rose at the ends to shallower depths, the milfoil field divided into two bands, the top of the dike being clear of milfoil. Wherever we looked, whoever looked, and whatever method they used, the pattern was the same. The milfoil grew from the bottom at depths between seven feet and fourteen feet.

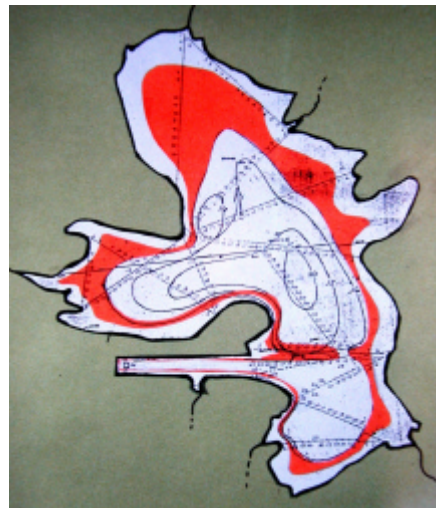
SLIDE #11 - MILFOIL FIELD

Using a depth chart of the lake to determine the area between the 7' and 14' depth contour lines, we determined that milfoil infested more than one hundred acres of our lake -- 20 to 25% of the area. The milfoil field is indicated here in orange.

Most significant was the regularity of the pattern. Based on the information that we had gathered, we concluded that in the deep water the milfoil growth had been limited by light penetration, while the upper boundary was a consequence of freezing due to winter exposure at our normal winter drawdown level. We realized that we were looking at very persuasive direct evidence that freeze-out was effective at our lake. The lower our winter level, the lower the milfoil boundary would be. What if the entire milfoil field were exposed over the winter?

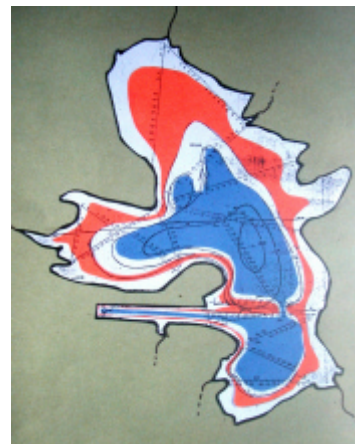
SLIDE #14 - MILFOIL BAND AND REMAINING WATER

The plan would result in all of the milfoil at Galway Lake, the orange zone, being exposed as the water area was reduced to the blue zone on this map. There was truly an opportunity to get it all.

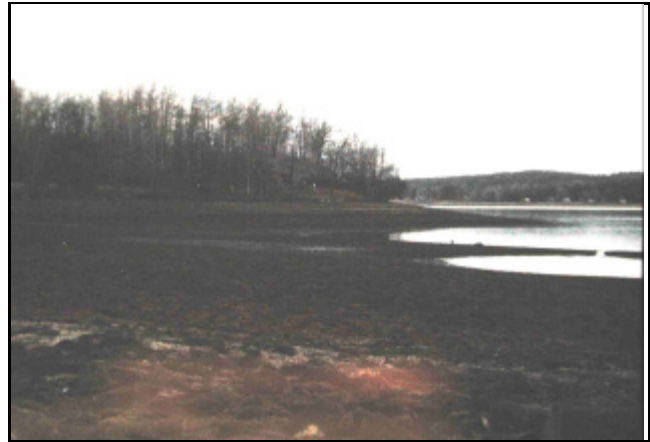
SLIDE #17 - EXAMPLE OF POND FORMING

Here is an example - the elimination of ponding, where fish could be trapped and milfoil could survive to re-infest. A channel (far right) was cut by a volunteer to assure drainage of the pond that was forming, and the area was checked for stranded fish. It was necessary to use boards to get out on the muddy bottom.

The exposed milfoil has a somewhat orange appearance in this photo. You can clearly see the upper (shallow depth) boundary of the infested area.

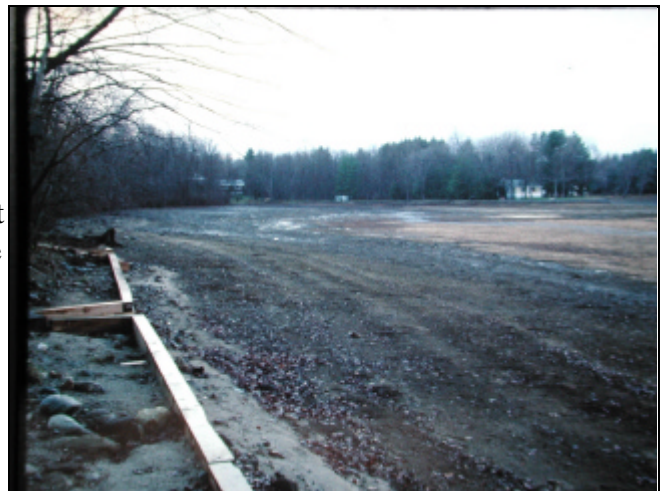
SLIDE #19 - DEEP DRAWDOWN (#1)

Now here are some views of what Galway Lake looked like in late fall of '89 when almost down to the target drawdown level. It's quite a contrast!

Note again the well-defined upper boundary of milfoil growth, approximately following the seven-foot depth contour line on both the near and far shores.

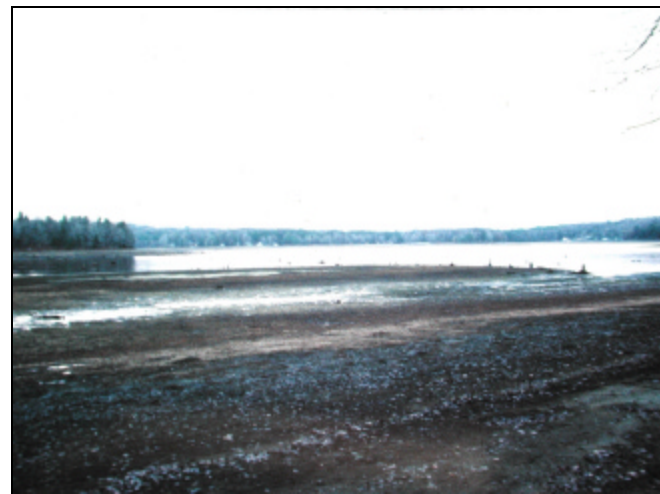
SLIDE #21 - DEEP DRAWDOWN (#3)

The lake level was below the lower milfoil growth boundary when the first deep freezes and snows came.

Winter of '89 was favorable for this operation, being severely cold and having less-than-normal snow cover. The result was virtually complete elimination of the milfoil at Galway lake for the Summer of '90.

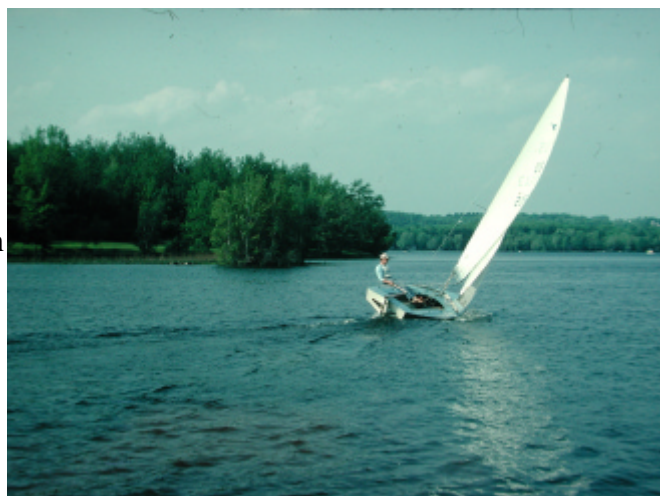
SLIDE #22 - SUMMER '90, NO MILFOIL!

Here we are with water again, summer of '90. The milfoil is gone. Although many people around the lake were looking for it, only one sighting of two isolated milfoil plants had been reported by the end of summer 1990. So far this season, the second summer after the deep drawdown, the lake is clear of milfoil. Quite an improvement from summer of '89, when 100+ acres were infested.
